Spindle Re-Conditioning Report

Mazak VTC-20G (20G-PC)

Noranco Pickering
February 20, 2020

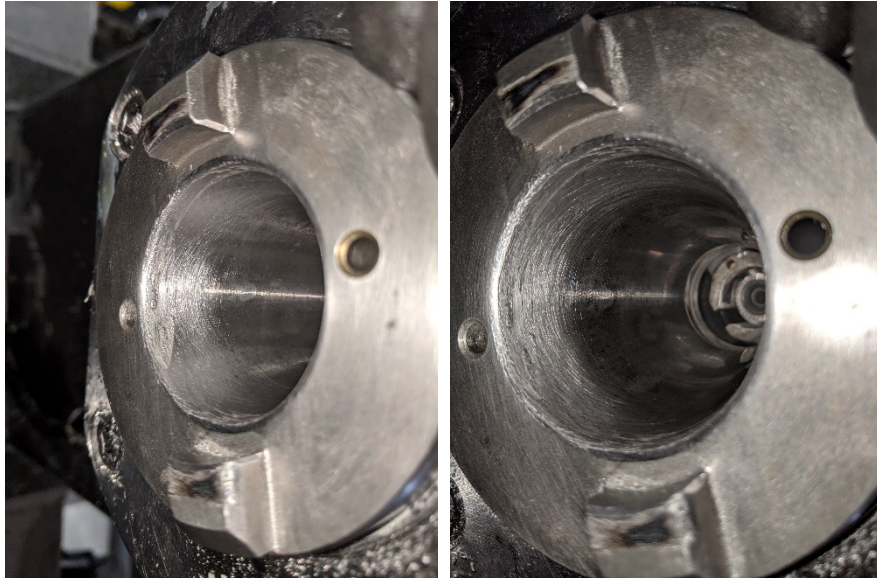
Spindle Condition As Found

- Spindle has cold welded material from the tool being pulled from the spindle.
- Spindle has been hand worked.
- There is a gouge towards the major diameter that may not be reasonably removable

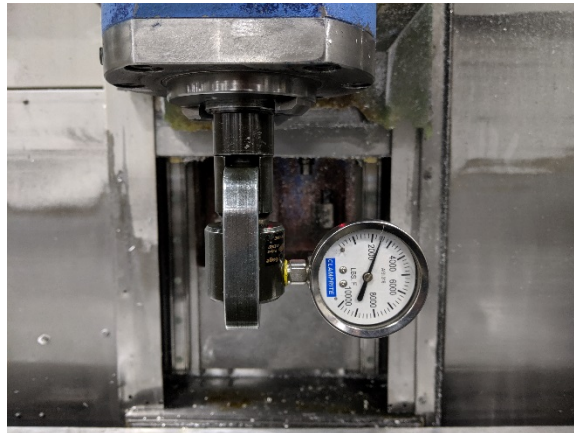
Clamping Force As Found

2500lbs

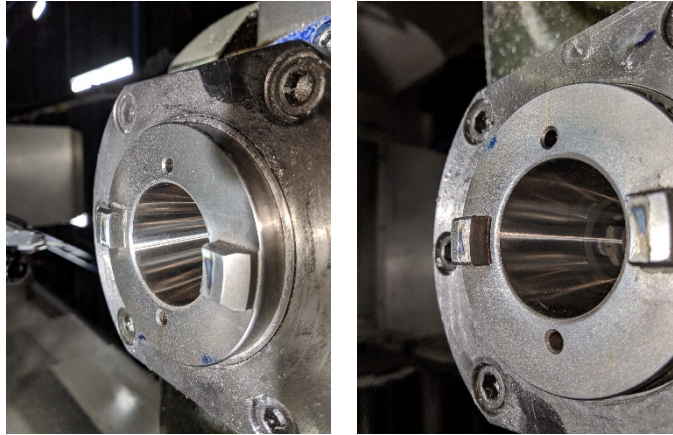
Spindle Condition Final

- Surface finish is good with a small inclusion remaining towards the major diameter.
- Restored taper contact to >98%

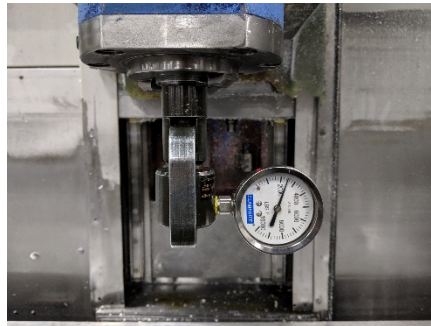
Spindle Clamping Force Final

2500 lbs

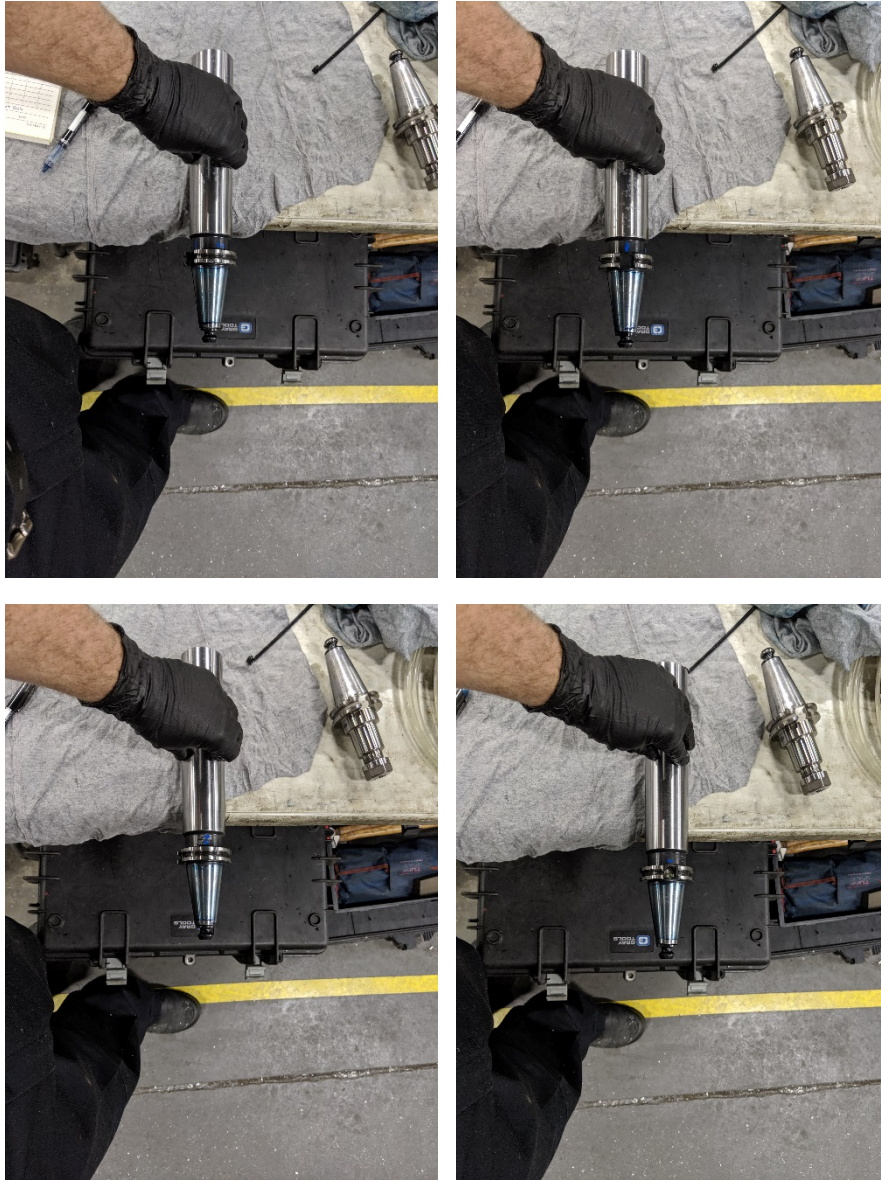
Spindle Transfer Test Final

Good even pressure throughout taper. >98%Contact.
